## PERFORMANCE OF FLOORING MATERIALS IN MILITARY KITCHENS

30 April 1964

8339

Thomas H. Boone  
Organic Building Materials Section  
Building Research Division

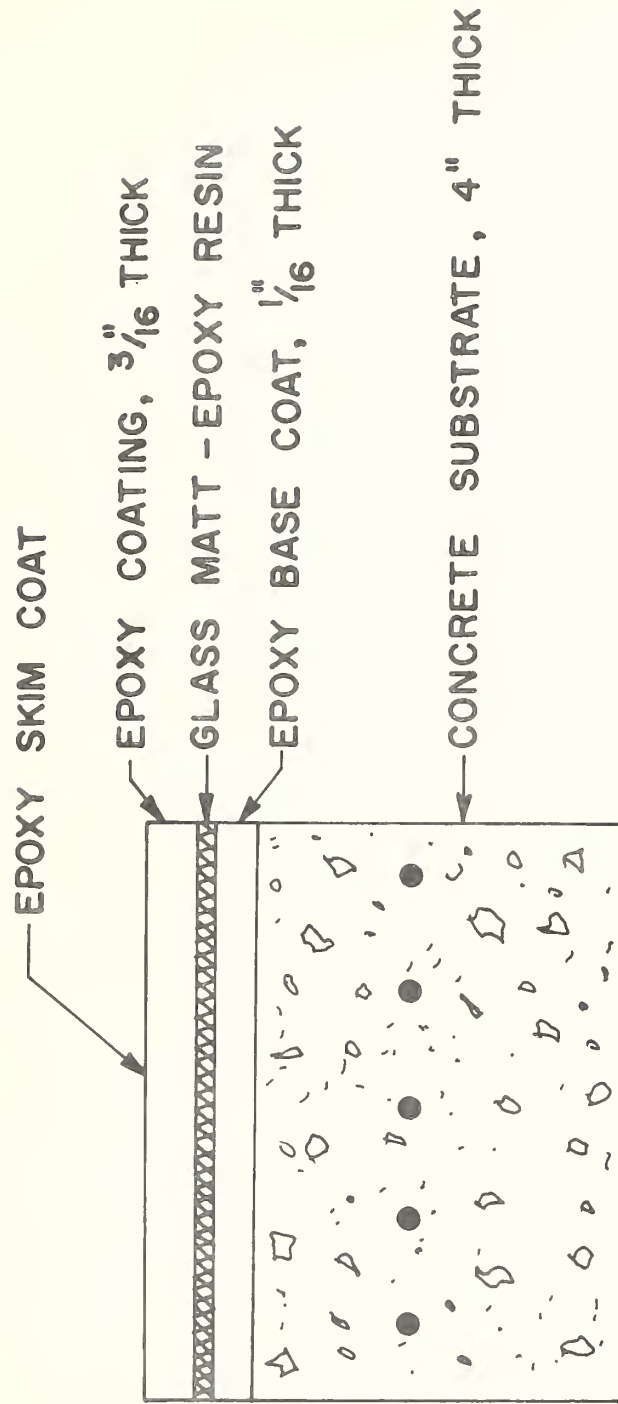
The concrete base of floor number 7 was cleaned with a hydrochloric acid solution, scrubbed, thoroughly rinsed with water, and dried. This installation was placed in August 1959, under the same conditions and temperatures as floor number 6. An epoxy sandfilled base coat was placed 1/16-inch thick with a glass matt overlay. A non-filled epoxy was worked into the top surface of the matt. Over this was placed two coats, a 3/16-inch filled coating and a high resin content skim coat (see Figure 2). The building was not occupied for 20 days.

- (1) bond failure between base epoxy and concrete at areas near ranges,
- (2) separation of skim coat from the body of the epoxy around the floor drain area,
- (3) numerous indentation spots caused by impact of food serving trays and garbage cans.

By the fall of 1960, this floor had completely failed. Large sections had delaminated, other sections had broken away from the concrete.

FIGURE 2. SCHEMATIC DIAGRAM OF TEST FLOOR NUMBER 7, MULTI-LAYER EPOXY COATINGS.

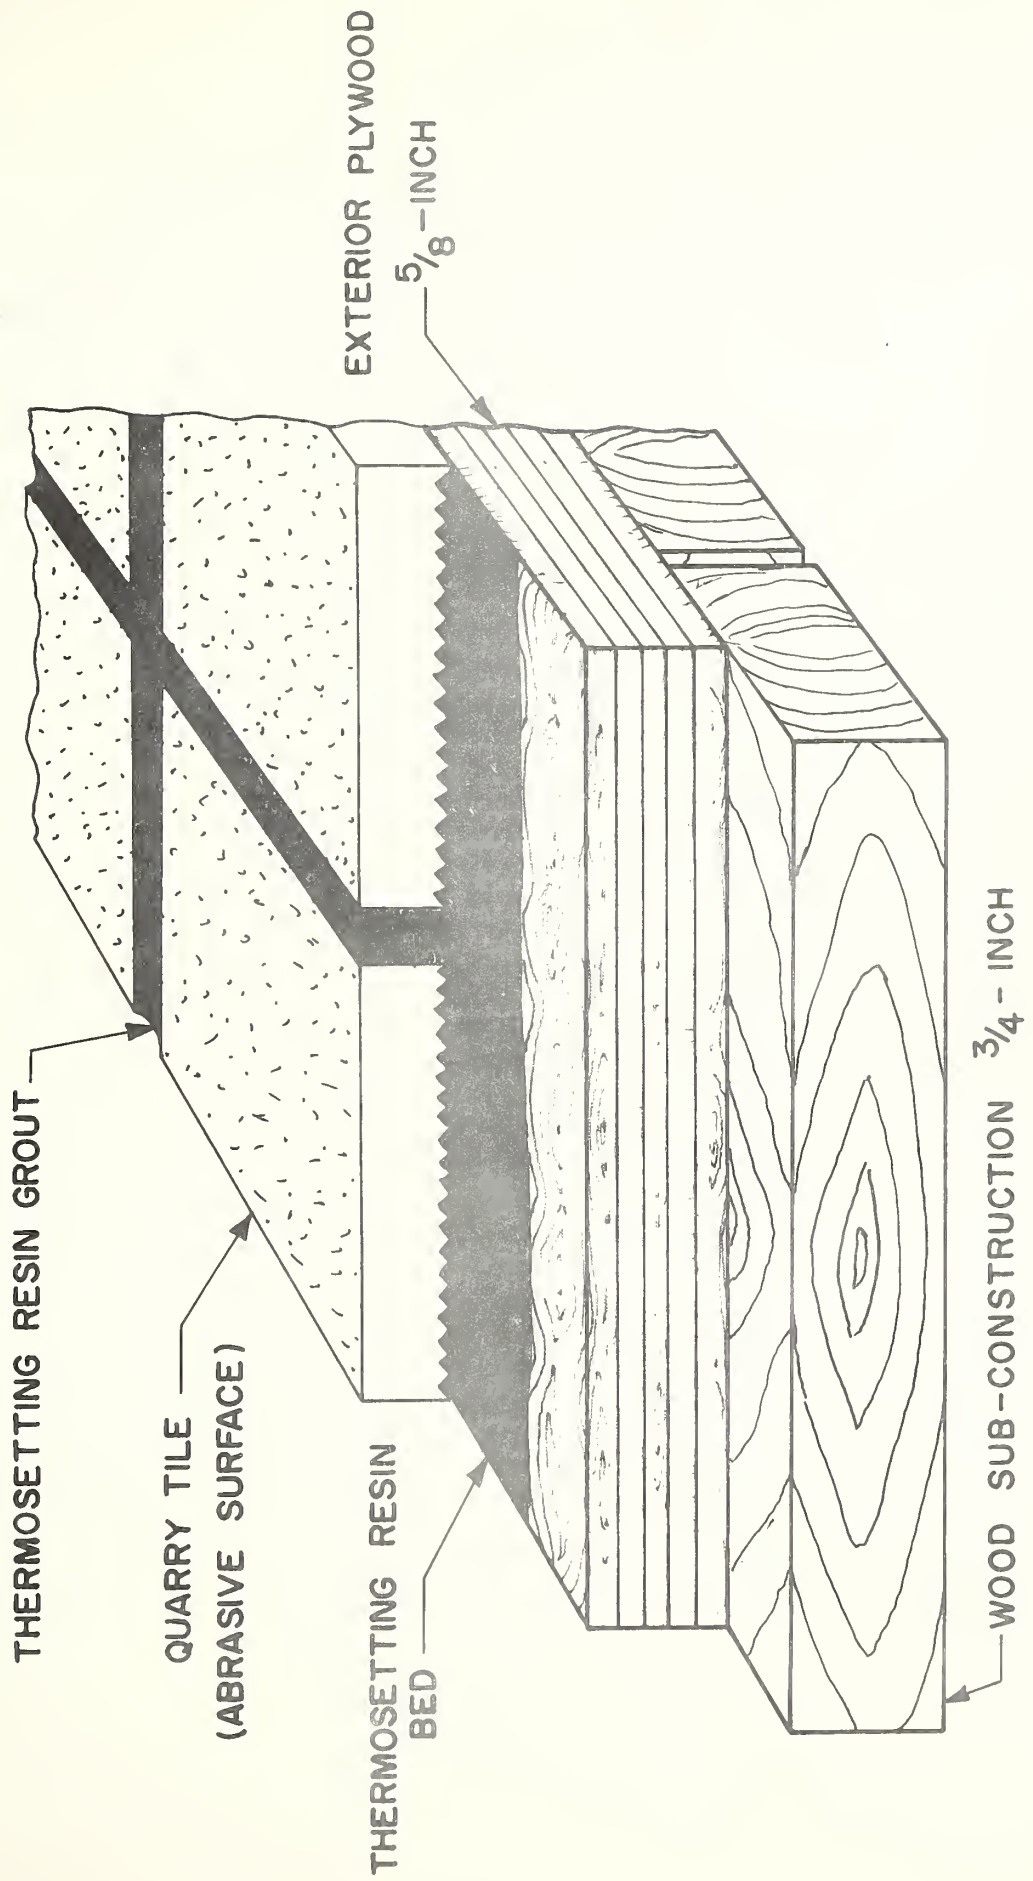
Non-slip conditions were obtained by using tile with aluminum oxide particles embedded in the surface. Two thermosetting resins, epoxy and furan, were investigated for better joints and bed mortars. A floor design was used on floors numbers 9 and 10 that would permit the installation of quarry tile over wood (see Figure 3).

FIGURE 3. QUARRY TILE FLOOR CONSTRUCTION OVER WOOD SUBFLOORING.
